## Repair, don't replace, burner-register linkages

Appalachian Power Co's (APC) Amos station has two 800-MW supercritical boilers, both installed in the early 1970s. Each produces 5.28-million lb/hr of 3515-psig/1010F main steam. After 20 years, normal wear and tear on the burner air registers have contributed to poor control-setting repeatability for the electric-actuator-driven secondary-air vanes. Proper register settings are crucial to establishing correct flame shape and stability. Improper register settings can lead to poor combustion efficiency, increased particulate emissions, accelerated slagging, and tube wastage.

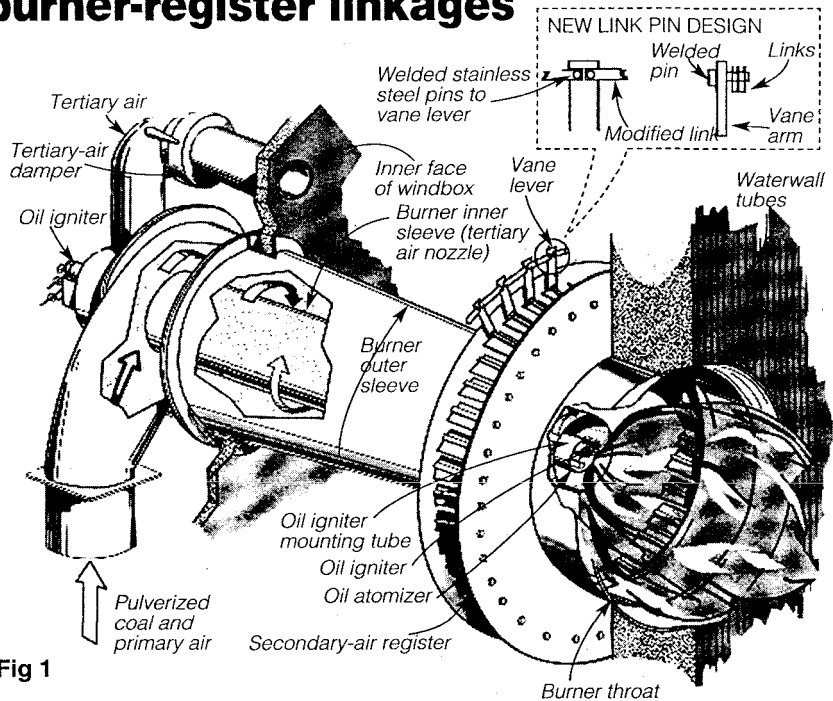
Fig 1

**Problem.** Close inspection by Amos plant engineers revealed substantial wear on the circumferential linkage assembly that connects all the secondary-air vane levers and permits simultaneous opening and closing of all vanes (Fig 1). The original hardware for each assembly includes sixty-six 7.5-in.-long carbon steel links that attach tangentially to the vane levers. At the end of each link is a 0.38-in.-diameter hole through which a loose link pin connects the link to a vane lever. The pin is secured by a washer and cotter pin at each end. Years of normal wear enlarged the holes in both the vane arms and links, resulting in excessive "play" between components—and vane settings that were off by up to 40%.

Amos personnel welded two stainless steel link pins at the end of each lever. New links were then installed. These were

identical to the originals except the end holes were drilled to have a diameter only 0.01 in. larger than that of the connecting pins. This tighter clearance both reduces play and limits the excessive wear rates associated with a loose, uneven fit. When the assembly does eventually wear, only the carbon-steel links should require replacement—instead of both the links and the vane arms, as was the case with the original design.

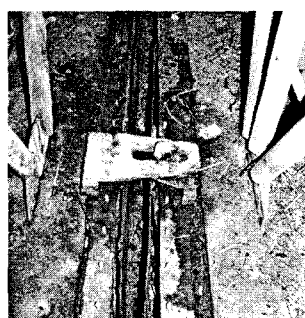
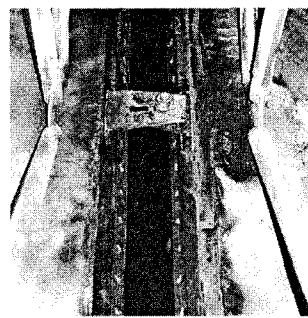
Each of two lines of ductwork connecting the air heater to the electrostatic precipitator at Ohio Power Co's Gavin station has 27 expansion joints. After nearly 20 years of service, many of the original metallic expansion joints were badly corroded and flue gas was leaking through to the atmosphere (Fig 4). These original joints consist of a double wall of Corten steel sandwiched around a layer of mineral-wool blanket insulation and protected from the flue-

Gavin's Elwood Lewis and American Electric Power Service Corp's (AEP) Glenn Davis devised an alternative to complete replacement: seal the existing joints in place. To do this, the existing metal dust shields were replaced with tough, <sup>3</sup>/<sub>16</sub>-in.-thick, Viton-coated, fabric-belt expansion joints (Fig 5). The belts, which look similar to black rubber mats, form a sturdy barrier inside the existing expansion joints.

To ensure a tight seal, plant personnel welded new steel frames on top of the backup bars of the original expansion joints. Next, threaded Corten studs, preattached to support bars, were welded to the frames. To ease final installation, the belt manufacturer prepunched stud holes near both edges of the belts. Thus, each belt was simply spliced to size, then secured in place with washers and locknuts.
